BELZONA REPAIRS VACUUM PUMP ROTOR

ID: 124

Industry: Sugar
Application: CEP-Centrifugal Pumps
Substrate: Cast Iron
Products: * Belzona® 1111 (Super Metal) ,
* Belzona® 1341 (Supermetalgilde) ,

Customer Location: Sugar Cane Mill in Minnesota, U.S.A.
Application Date: 1993

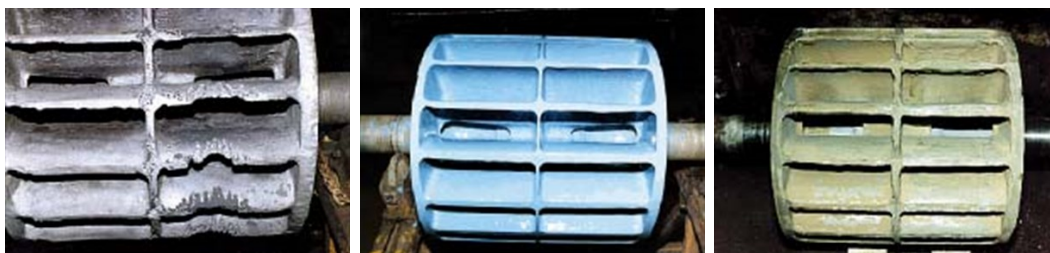
Cavitation damage was the principal problem on this rotor.

- * Extensive damage of vacuum pump easily visible. ,
- * Refurbished rotor. ,
- * Rotor after many years in service. ,

The application was carried out in accordance with Belzona Know-How Leaflet CEP-1.

Belzona's repair system has proven resistant to cavitation. The repair has lasted over five years.
