TANK BASE SEALING WITH BELZONA PRODUCT

ID: 1240

Oil storage tank.

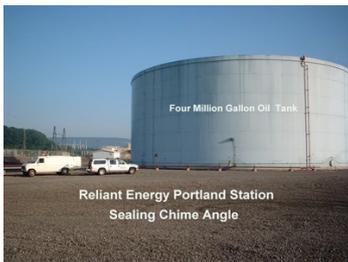
- * View of the tank ,
- * Chime angle before application ,
- * & 4. Finished application ,

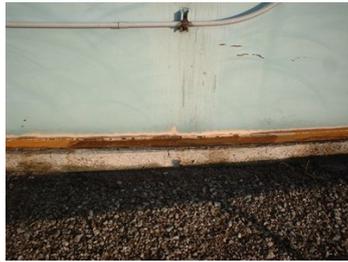
Corrosion at chine angle and water getting under the tank bottom
