TANK BASE SEALING WITH BELZONA PRODUCT

ID: 1240

Industry: Power

Customer Location: Power Station, Portland, Philadelphia
USA

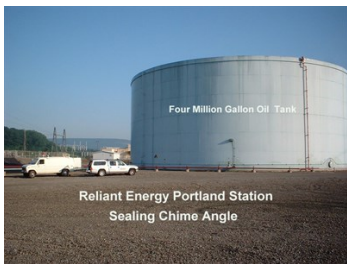
- * View of the tank ,
- * Chime angle before application ,
- * & 4. Finished application ,

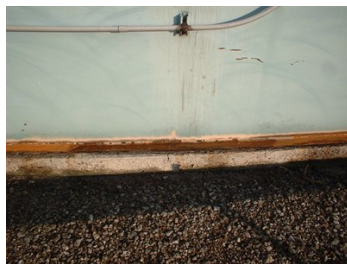
Corrosion at chine angle and water getting under the tank bottom
