# CLASSIC BELZONA SHAFT REPAIR AT CEMENT PLANT

Industry: *Cement*  
Application: *MPT-Mechanical Power Transmission*

Customer Location: *Cement plant, Nazareth, PA*  
Application Date: *November 2005*

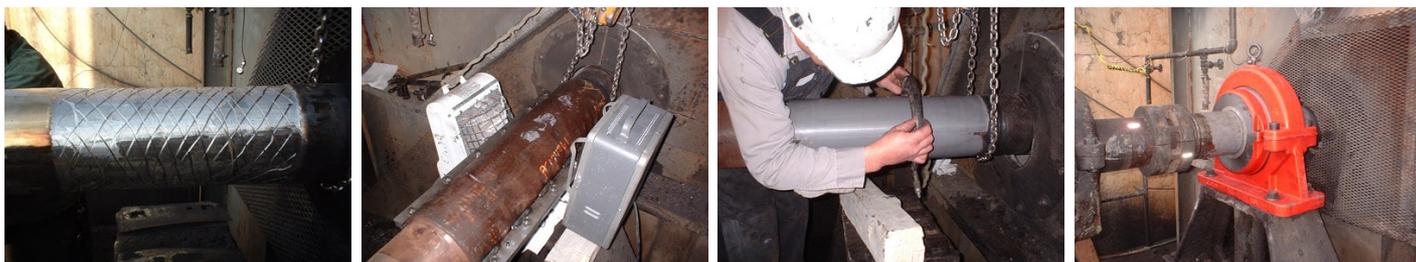
## Photograph Descriptions

*Kilns were to be shut down in approximately 4-6 weeks but failed split bearing caused scoring of shaft requiring urgent repair.*

\* Shaft prepared , \* Split sleeve former , \* Rebuilt shaft being measured , \* Back in service ,

Forced draft fan shaft for the kilns.

Application was completed in accordance with Belzona Know-How System Leaflet MPT-2.
