# BELZONA SEALS COOLING TOWER LEAKS

**Industry:** Heating, Ventilation & Air Conditioning  
**Application:** RPA-Roof Problem Areas  
**Substrate:** Galvanized steel  
**Products:** \* Belzona® 3111 (Flexible Membrane),

**Customer Location:** Hospital, Minneapolis, Minnesota USA  
**Application Date:** Summer 2008

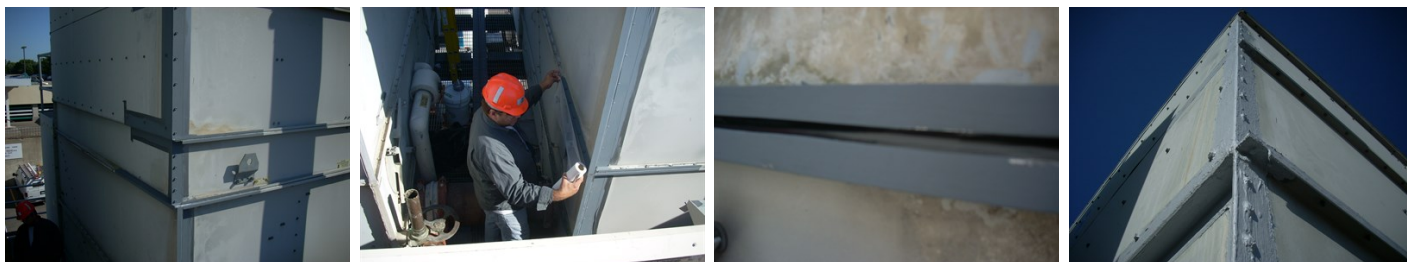
## Photograph Descriptions

Cooling towers leaked from seams. The leaks froze the belt and motor drive in the winter.

- \* Belzona® 3921 applied to prepared area ,
- \* Applying bond breaker tape ,
- \* Applying Belzona® 9311 (Reinforcing Sheet) ,
- \* Application completed with Belzona® 3111 ,

Application was carried out in accordance with Belzona Know-How System Leaflet RPA-1. A fully reinforced Belzona® 3111 system was applied using Belzona® 3921 Conditioner.
