BELZONA SEALS COOLING TOWER LEAKS

ID: 1245

Customer Location: Hospital, Minneapolis, Minnesota USA
Application Date: Summer 2008

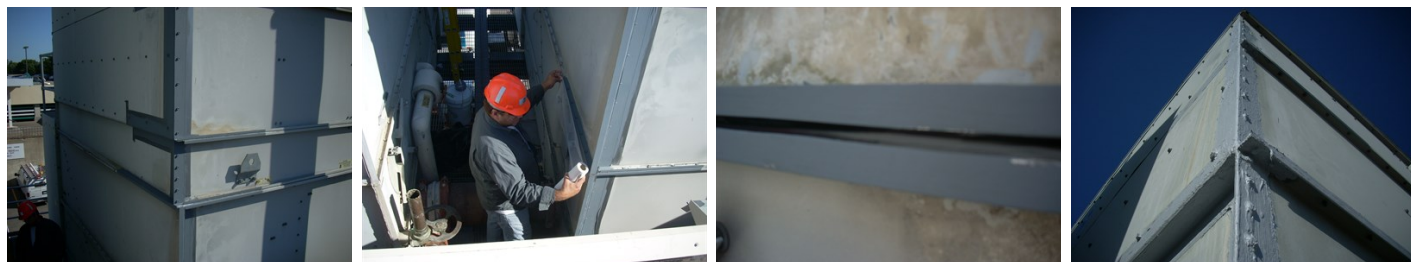
Photograph Descriptions

Cooling towers leaked from seams. The leaks froze the belt and motor drive in the winter.

- * Belzona® 3921 applied to prepared area ,
- * Applying bond breaker tape ,
- * Applying Belzona® 9311 (Reinforcing Sheet) ,
- * Application completed with Belzona® 3111 ,

Application was carried out in accordance with Belzona Know-How System Leaflet RPA-1. A fully reinforced Belzona® 3111 system was applied using Belzona® 3921 Conditioner.
