STORAGE TANK ROOF REPAIRED USING BELZONA

ID: 1247

Customer Location: Petroleum Company, Egypt.
Application Date: December, 2008.

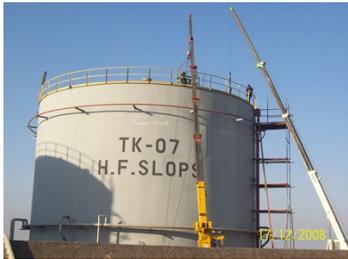
Several holes in the tank roof.

- * General view of the tank ,
- * The holes in the roof tank ,
- * Using two winches to carry the metal sheets & technicians ,
- * Application completed ,

Application was carried out in accordance with Belzona Know-How System Leaflet TCC-1. Metal patches were formed to cover the holes and were bonded into place using Belzona Marine metal. The unsafe roof forced the applicators to use winches to support the plates and technicians on the tank to solve the problem.
