BELZONA REPAIR AND PROTECTION OF DESALTER

ID: 1250

Customer Location: Petroleum Company, Egypt.

Application: TCC-Tanks and Chemical Containment Areas

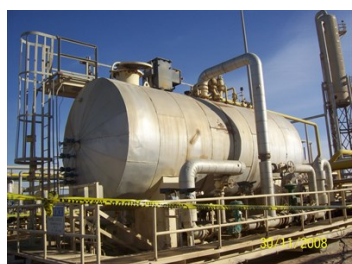
Several pitted areas in the lower half of the vessel needed to be rebuilt. Protection then required particularly for high salt levels in lower half of vessel.

* General view of the Desalter , * Rebuilding the pitting areas in the lower half , * Finishing the coating of the upper half , * Application completed ,
