BELZONA GETS GRIP ON CONVEYOR SLIPPAGE

ID: 1256

Industry: Mining & Quarrying
Application: SHM-Solids Handling Machinery

Customer Location: Quarry, Central Missouri
Application Date: January 2009

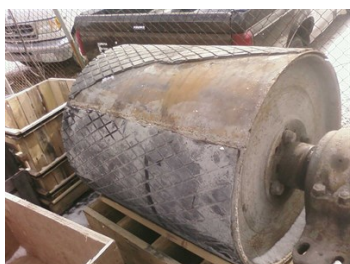
Pieces of rubber lagging were frequently torn loose due to build up. Excessive wear from moisture, chemical attack and abrasive media was causing belt to slip. Belt would often not track properly due to uneven lagging pads.

* Head pulley with damaged rubber lagging Grit blasted pulley Belzona non-slip surface Completed and ready for service ,
