Belzona Repairs Cavitation Damage on Potable Water Pump.

Customer Location: Water Treatment Plant, Virginia.

Application: CEP-Centrifugal Pumps

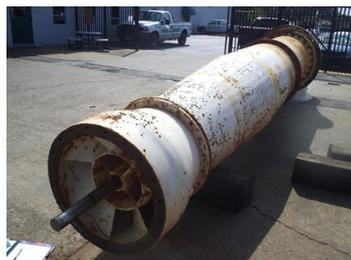
Suction bowl badly damaged by cavitation.

* 24 inch vertical potable water Pump , * Suction Bell shown with severe cavitation damage. Pump repaired with Super Metal , * Pump back in shop vibration issues. Inspection shows minor damage to old repairs , * Belzona Super E Metal used to repair minor cavitation damage. ,

January 2006: Lost metal replaced with Belzona® 1111. Strength added to casing by welding steel stiffeners to outside of casing.
