Belzona Repairs Cavitation Damage on Potable Water Pump.

ID: 1259

Application: CEP-Centrifugal Pumps

Customer Location: Water Treatment Plant, Virginia.

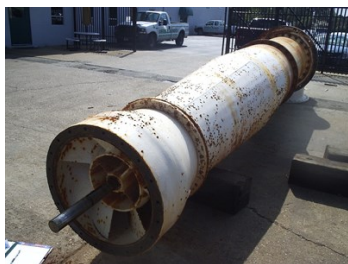
* 24 inch vertical potable water Pump , * Suction Bell shown with severe cavitation damage. Pump repaired with Super Metal , * Pump back in shop vibration issues. Inspection shows minor damage to old repairs , * Belzona Super E Metal used to repair minor cavitation damage. ,
