# CAVITATED PUMP DIFFUSER RESTORED WITH BELZONA

ID: 1261

Customer Location: Theme Park, (Southeast) Virginia  
Application Date: March 2009

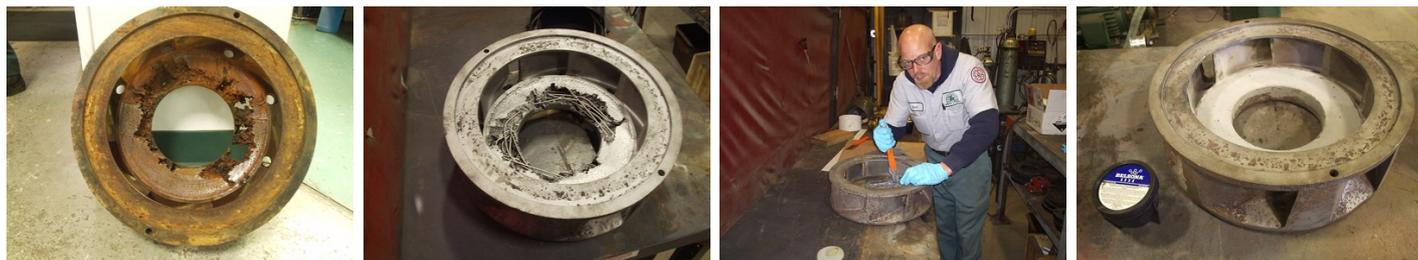
Cavitation had caused severe metal loss to pump impeller and diffuser. New impeller was available but no diffuser available.

- \* Severely cavitated diffuser ,
- \* Diffuser blasted and rebar tack welded in place ,
- \* Belzona® 1111 application ,
- \* Completed repair ,

Application was carried out in accordance with Belzona System Leaflet CEP-1. Pump shop tack welded "rebar" into deeply cavitated areas. Belzona® 1111 applied to replace lost metal. Belzona machined to original diffuser dimensions.

Old pump and new diffuser not available. \$450 of Belzona used to quickly and effectively repair this valuable component.
