STORM WATER PUMP PROTECTED WITH BELZONA FOR 10 YEARS

ID: 1262

Application: CEP-Centrifugal Pumps

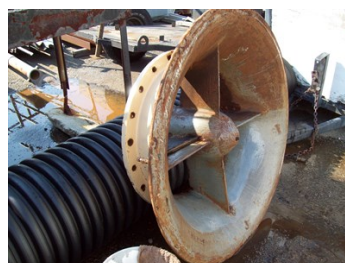
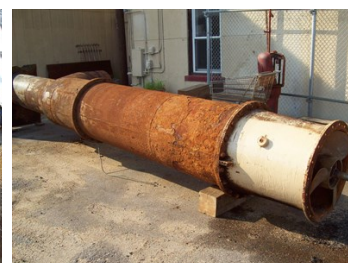
Photograph Descriptions

Original pump deteriorated due to erosion corrosion. City decided to protect suction bell and diffuser with Belzona coatings before placing into service.

- * Suction Bell coated in 1998 ,
- * Diffuser coated in 1998 ,
- * Suction Bell in 2008 ,
- * Diffuser in 2008 ,

Application was carried out in accordance with Belzona Know-How System Leaflets CEP-3 and CEP-4. New pump was disassembled at local repair facility. Suction bell and diffuser blasted and coated with Belzona® 1321 internally and Belzona® 5811 externally.

successful service to replace it with a larger pump. An after service inspection revealed that 100% of the Belzona® 5811 was intact and 95+% of the Belzona® 1321 was intact.
