STORM WATER PUMP PROTECTED WITH BELZONA FOR 10 YEARS

ID: 1262

Application: CEP-Centrifugal Pumps

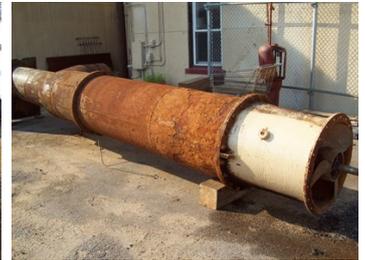
Original pump deteriorated due to erosion corrosion. City decided to protect suction bell and diffuser with Belzona coatings before placing into service.

- * Suction Bell coated in 1998 ,
- * Diffuser coated in 1998 ,
- * Suction Bell in 2008 ,
- * Diffuser in 2008 ,

Application was carried out in accordance with Belzona Know-How System Leaflets CEP-3 and CEP-4. New pump was disassembled at local repair facility. Suction bell and diffuser blasted and coated with Belzona® 1321 internally and Belzona® 5811 externally.

successful service to replace it with a larger pump. An after service inspection revealed that 100% of the Belzona® 5811 was intact and 95+% of the Belzona® 1321 was intact.
