EVAPORATOR BARREL PROTECTION WITH BELZONA

ID: 1264

Application: SHM-Solids Handling Machinery

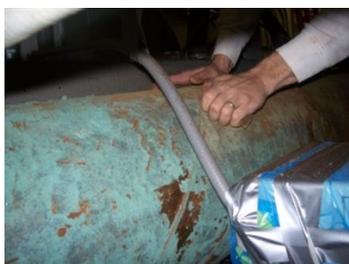
The evaporator barrel is corroding from the inside out and springing leaks, which causes a temporary shutdown to repair the leak. The customer wanted a solution that would allow them to keep operating should a leak occur until they could plan a shutdown for a more permanent repair or replacement.

- * Preparation of the barrel ,
- * Application of the first coat and reinforcing sheet ,
- * Completed application of second coat ,
- * Completed application ,

The application was carried out with a modified version of Belzona Know-How System Leaflet. An orbital sander with a scotch brite pad was used to lightly abrade the surface, which was too thin to achieve an ideal preparation. The surface was cleaned with MEK. A heavy coat of Belzona 2121 was applied, the barrel was wrapped with Belzona 9331 and a second heavy coat of Belzona 2121 was applied.
