BELZONA PROVIDES LONG TERM REPAIRS TO CLARIFIER

ID: 1265

Customer Location: Sewage treatment plant, South East Virginia

Application: TCC-Tanks and Chemical Containment Areas

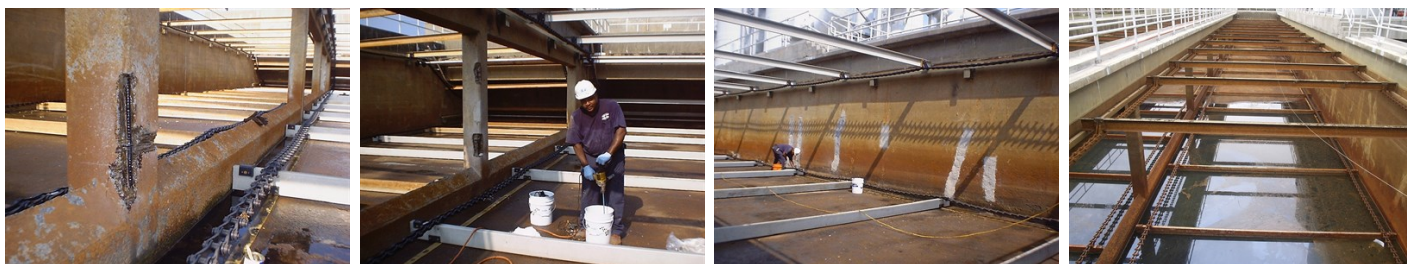
Photograph Descriptions

Severe cracks appearing in concrete walls and spalling concrete over re-bar on columns.

- * Spalled concrete on vertical column prepared and conditioned ,
- * Spalling on vertical columns being repaired with Belzona® 4141 ,
- * Cracks in Wall repaired with Belzona® 4111 ,
- * Picture of clarifier in 2008 after 5 years service ,

Application was carried out in accordance with Belzona Know-How System Leaflet TCC-9. Belzona® 4141 used to rebuild spalled columns and Belzona® 4111 used on cracked walls.

Customer previously used lower cost alternatives but did not last for long. These Belzona repairs in the Clarifier have been in service for 5 years without failure.
