BELZONA REPAIRED RECYCLING DRUM LASTS 12 YEARS

ID: 1266

Industry: *Pulp & Paper*
 Application: *TCC-Tanks and Chemical Containment Areas*
 Substrate: *Carbon Steel*
 Products: ** Belzona 1311 (Ceramic R-Metal) ,*
** Belzona 1321 (Ceramic S-Metal) ,*

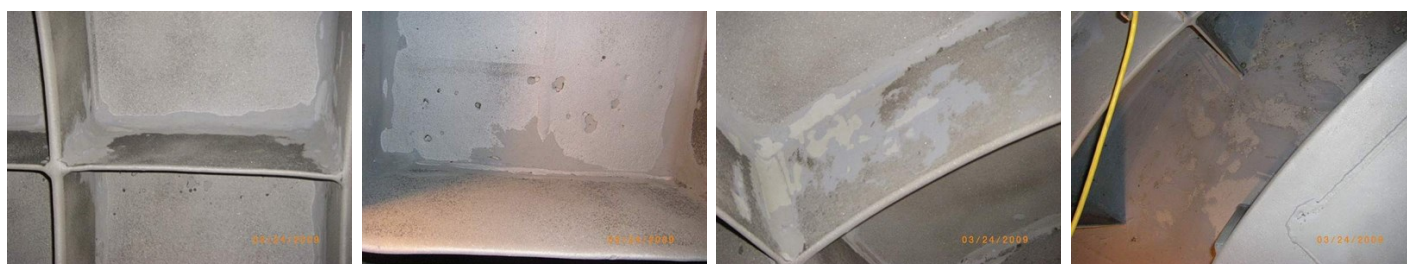
Photograph Descriptions

Bi-metallic corrosion on approximately 70% of the weld.

- * Remaining Belzona 1311 from application 12 years ago ,
- * Additional remaining Belzona 1311 from original application ,
- * Remaining Belzona 1321 from application 12 years ago ,
- * Additional remaining Belzona 1321 from original application ,

The application was carried out in accordance with a modified version of Belzona Know-How System Leaflet TCC-5.

The application literally saved millions of dollars in replacement costs and downtime. The pictures show how much Belzona Ceramic R-Metal is left protecting the incompatible welds and Ceramic S-metal is left protecting the surface of the steel. Inspection of the application after 12 years of continuous service and sandblasting with coal slag proves that Belzona provided the right solution for
