# CHURCH HAS LONG HISTORY WITH BELZONA

**Application:** RPA-Roof Problem Areas

**Customer Location:** Church, Richmond, Virginia USA

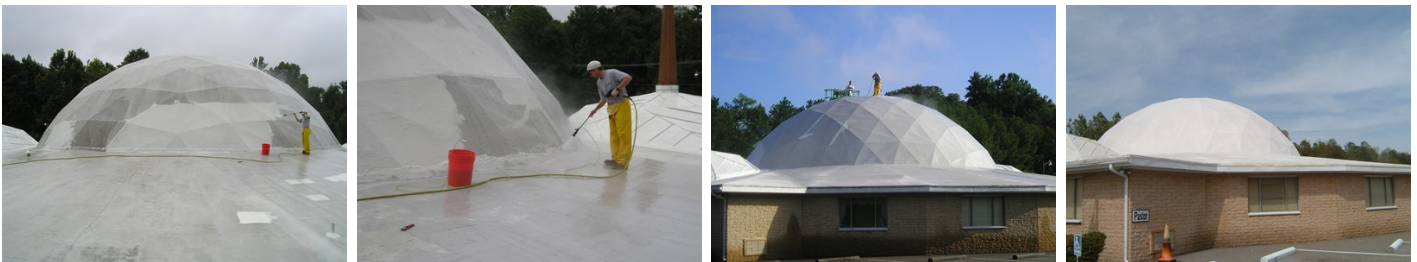
## Photograph Descriptions

The dome roof has a lot of movement and was very hard to keep from leaking.

\* 1. & 2. Applying Belzona Flexible Membrane ,

\* 3. Spraying the top of the dome ,

\* 4. The roof in 2006 ,

Application was carried out in accordance with Belzona Know-How System leaflet RPA-1. Spray application was used to aid application.

Belzona has provided an attractive and economical solution that effectively sealed the roof for the church. The original tar roof proved unsatisfactory. Belzona® 3111 was applied in the mid 1980s and proved to be a successful solution for approximately 20 years. The Church was so happy with the Belzona solution that they decided to restore the roof with a new application of Belzona® 3111 in 2004. The church continues to look to Belzona for solutions for its structural problems.
