# BELZONA PROTECTS OIL GAS SEPARATORS

ID: 127

Application: TCC-Tanks and Chemical Containment  
Areas

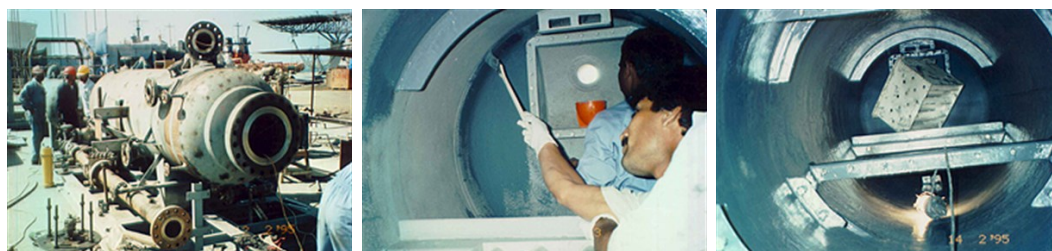
Severe deterioration to the internal surfaces of the vessels due to erosion-corrosion and SRB attack.

- \* General view of separator ,
- \* Application of Belzona® 1391 underway in a confined internal space ,
- \* Completed application to all internal surfaces of the separator ,

The application was carried out in accordance with the Belzona Know-How Leaflet TCC-3
