# SUCTION BELLS RESTORED WITH BELZONA

**Industry:** Power  
**Application:** CEP-Centrifugal Pumps  
**Substrate:** Cast Iron  
**Products:** \* Belzona® 1311 (Ceramic R Metal) ,  
\* Belzona® 1321 (Ceramic S Metal) ,  
\* Belzona® 5811 (Immersion Grade) ,

**Customer Location:** Power Plant, Missouri  
**Application Date:** May 2009

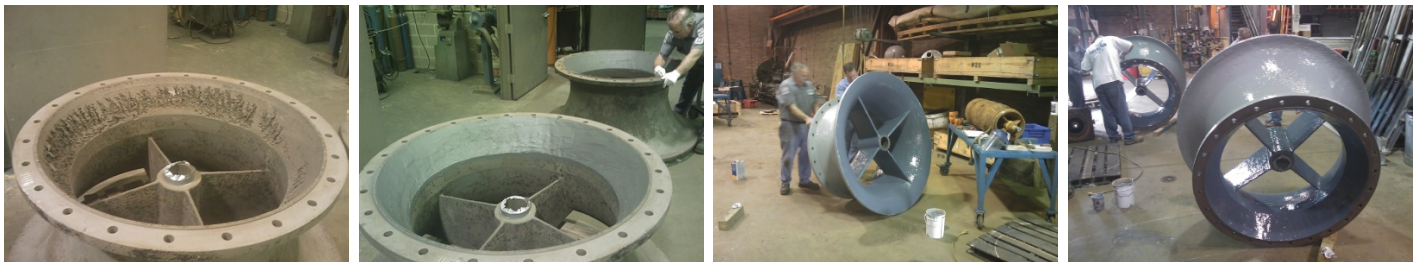
## Photograph Descriptions

Erosion had caused serious loss of metal with holes completely through the substrate in places. Loss of efficiency and unscheduled downtime lead client to look at replacing the items.

- \* Erosion clearly evident ,
- \* Belzona® 1311 being applied ,
- \* Belzona® 1321 applied to internal surfaces ,
- \* Belzona® 5811 applied to external surfaces ,

Bells were sandblasted to a white to near Application was carried out in accordance with Belzona System Leaflets CEP-3, CEP-4, and CEP-5. Belzona® 1311 applied to bring housing back to original dimensions. The internals were then coated with Belzona® 1321 and exterior with Belzona® 5811.
