# EMERGENCY LEAK SEALING ON TRANSFORMER WITH BELZONA

ID: 1278

450 kVA transformer for the electrical supply of the local water pump station.

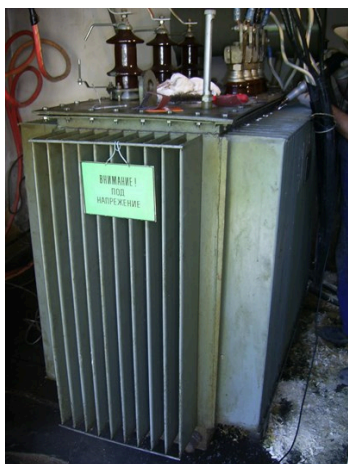
Leaks of transformer oil on porous and cracked welds

\* General view of the transformer , \* Close view of surface preparation , \* Belzona® 1291 applied to stop live leaks , \* Belzona® 1161 applied over the problem area ,
