# BELZONA PROTECTS PIPE ELBOWS FROM ABRASION

ID: 1280

Industry: *Mining & Quarrying*

Application: *SHM-Solids Handling Machinery*

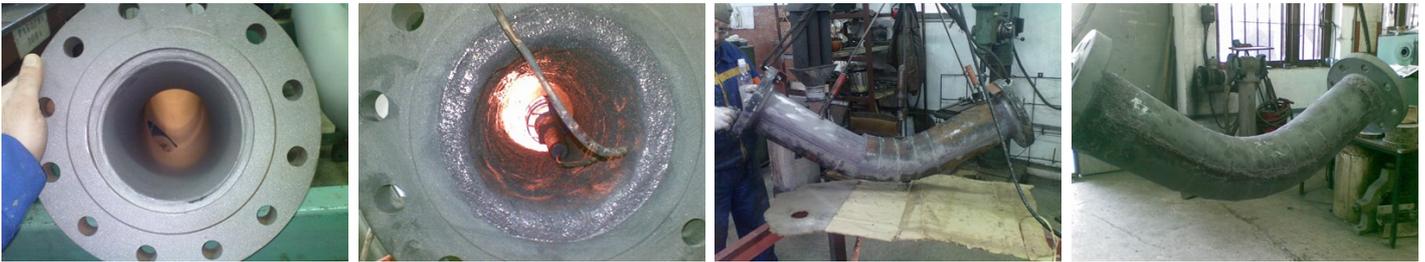
*Severe abrasion damage on inside surfaces of the pipe elbows.*

\* Abrasion damage clearly viewable after blasting  
Application of internal protective coating  
External bonding of metal doubler plates  
Finished protected pipe elbow ,

Application was carried out in accordance with Belzona Know-How System Leaflet SHM-8. Belzona® 1811/1812 have been used to protect elbows from further abrasion attacks. Application was either internal coating (for 6 inch diameter) with Belzona® 1812 or external bonding of metal doubler plates (for 4 inch diameter) with Belzona® 1811.

Previously customer had to replace non-protected elbows every three-five days or to use expensive but unsuccessful welding. Pipe elbows have been and continue to be protected with Belzona, increasing the working live to more than a month. As a result the customer saved money on replacement costs.
