BELZONA REBUILDS OVERSIZED PINTLE HOUSING

ID: 1281

Industry: *Marine*
Application: *SOS-Ships and Offshore Structures*

Customer Location: *Dockyard, Bulgaria*
Application Date: *February, 2009*

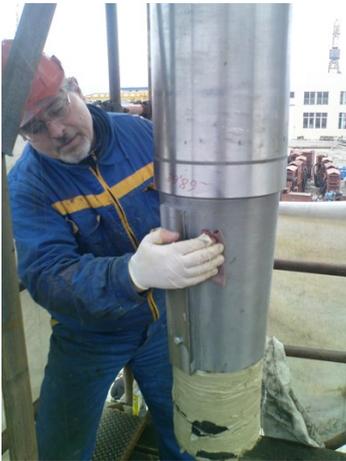
Keyway and rudder pintle housing were oversized due to erosion corrosion and impact.

- * Rudder pintle with false key used as former ,
- * Adjusting unit for rudder pintle positioning ,
- * After application of Belzona® 1111 the rudder stock was positioned ,
- * The oversized housing and keyway restored to exact profile ,

Application procedures were made according to Belzona Know-How System Leaflet SOS-3. The oversized housing and keyway were rebuilt using the rudder pintle with a false key as former. Belzona® 1111 was used for the main repair and Belzona® 1221 was used to fill some voids along keyway.

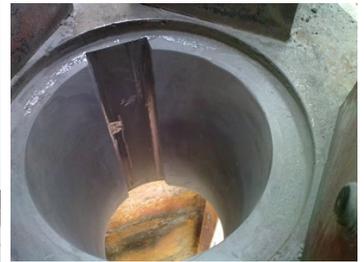
Oversized housing and keyway of rudder pintle.

The repair was done on-site and completed in a few hours. In this situation conventional repair by welding and then machining was considered to be time consuming, complicated and too expensive.
