# BELZONA REBUILDS OVERSIZED PINTLE HOUSING

ID: 1281

Industry: *Marine*  
Application: *SOS-Ships and Offshore Structures*

Customer Location: *Dockyard, Bulgaria*  
Application Date: *February, 2009*

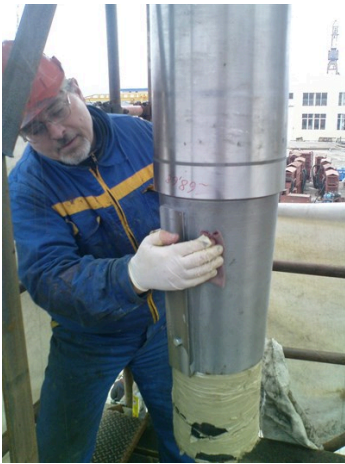
- \* Rudder pintle with false key used as former ,
- \* Adjusting unit for rudder pintle positioning ,
- \* After application of Belzona® 1111 the rudder stock was positioned ,
- \* The oversized housing and keyway restored to exact profile ,

Application procedures were made according to Belzona Know-How System Leaflet SOS-3. The oversized housing and keyway were rebuilt using the rudder pintle with a false key as former. Belzona® 1111 was used for the main repair and Belzona® 1221 was used to fill some voids along keyway.
