# BELZONA RESEATS BEARING BUSHES IN STEERING GEAR

ID: 1282

Industry: *Marine*  
Application: *SOS-Ships and Offshore Structures*

Customer Location: *Ship Dockyard, Bulgaria*  
Application Date: *June, 2008*

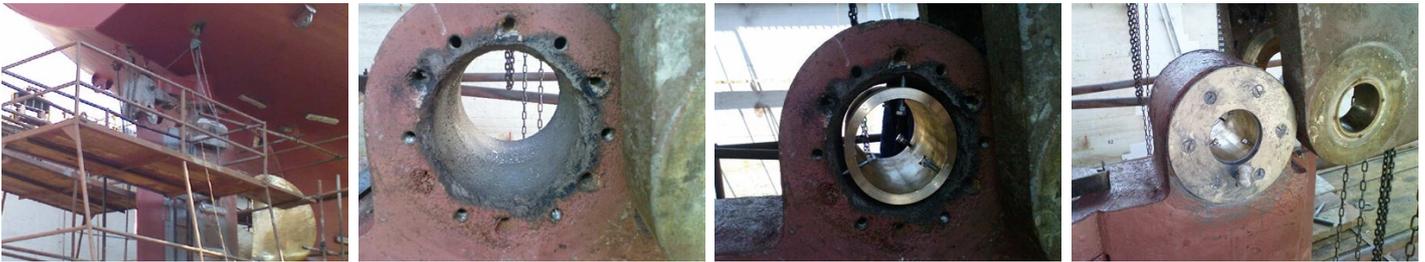
*Bimetallic corrosion caused wear of bush housing with further damage caused by the increased vibration in the rudder steering system.*

- \* General view of the rudder steering system ,
- \* Close view of the worn housing after blasting ,
- \* Reseating of the new bronze bush at the exact position ,
- \* Injection of Belzona® 1321 through injection ports in side flanges completed ,

Application procedures were carried out in accordance with Belzona Know-How System Leaflet SOS-9. Prefabricated new bronze bushes and side flanges were resealed in their positions and secured by injection with Belzona® 1321.
