# BELZONA REPAIRS AND PROTECTS VESSEL SUPPORTS

**Industry:** Chemical & Petrochemical  
**Application:** TCC-Tanks and Chemical Containment Areas  
**Substrate:** Concrete and Steel  
**Products:** \* Belzona® 4111 (Magma Quartz) ,

**Customer Location:** Chemical plant, Bulgaria  
**Application Date:** July, 2008

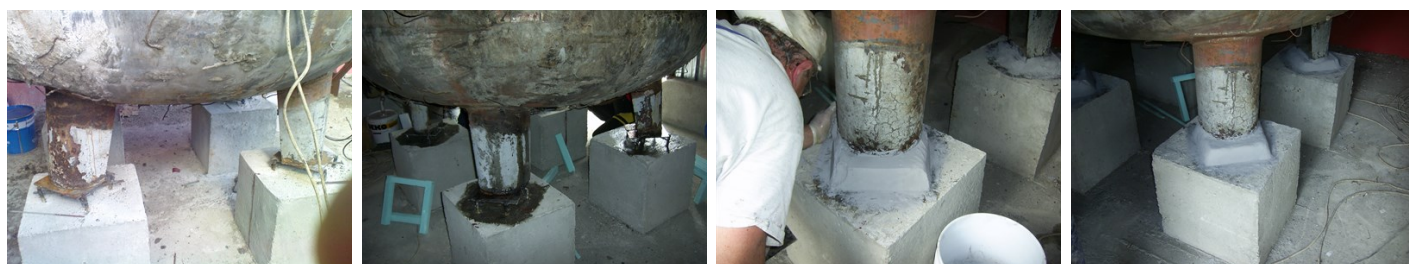
## Photograph Descriptions

Uneven gaps (up to 70 mm) and additional deterioration of the concrete supports under mixer heels caused by chemical attack.

- \* General view of process vessel heels and concrete supports ,
- \* After preparation of substrates the Belzona Conditioner was applied ,
- \* Application of Belzona® 4111 in progress ,
- \* Finished application ,

Application was carried out in accordance with the modified version of Belzona Know-How System Leaflet TCC-8. The irregular shim was created by filling the gaps between vessel heels and concrete supports with Belzona® 4111.
