BELZONA REPAIRS AND PROTECTS VESSEL SUPPORTS

Customer Location: Chemical plant, Bulgaria
Application Date: July, 2008

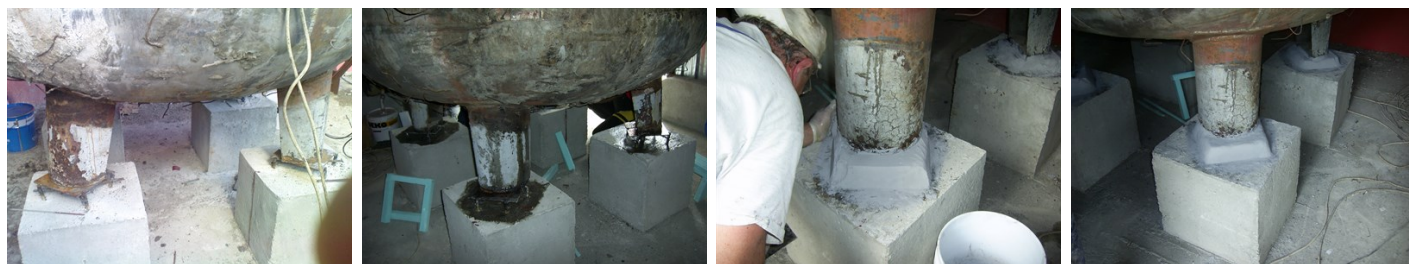
Photograph Descriptions

Uneven gaps (up to 70 mm) and additional deterioration of the concrete supports under mixer heels caused by chemical attack.

- * General view of process vessel heels and concrete supports ,
- * After preparation of substrates the Belzona Conditioner was applied ,
- * Application of Belzona® 4111 in progress ,
- * Finished application ,

Application was carried out in accordance with the modified version of Belzona Know-How System Leaflet TCC-8. The irregular shim was created by filling the gaps between vessel heels and concrete supports with Belzona® 4111.
