# Belzona Repairs and Waterproofs a Ship Hull

ID: 1286

Industry: *Marine*  
Application: *SOS-Ships and Offshore Structures*

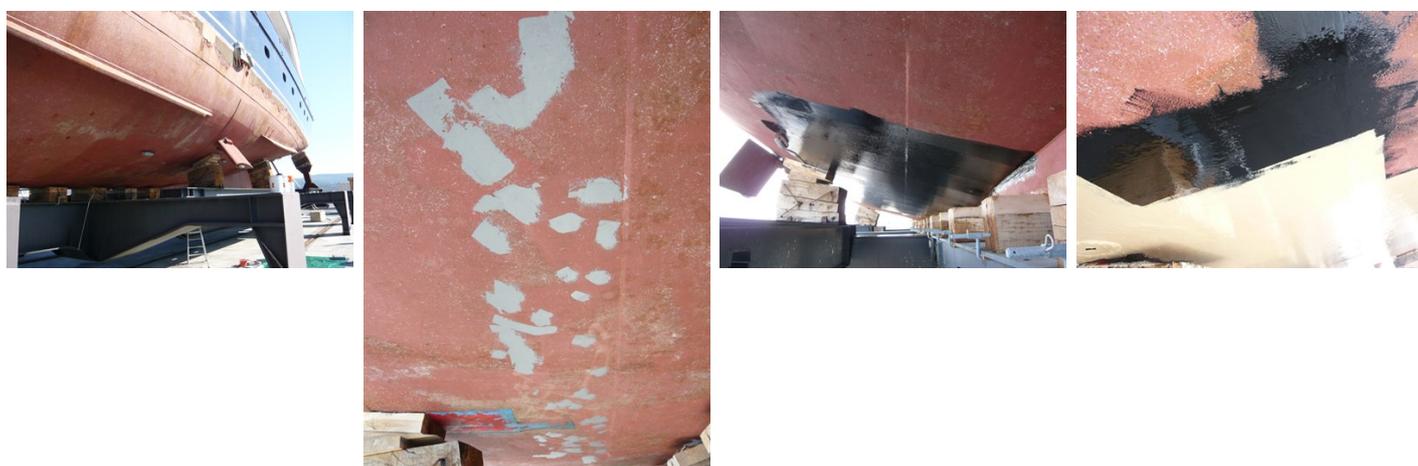
*Lead ballast have been stored in the engine room, leading to galvanic corrosion with the hull. This led to heavy pitted areas, creating issues regarding the waterproofing of the hull. The ship has to be tugged to another dockyard for replacement of the metal frame.*

- \* The ship's hull. ,
- \* Belzona 1161 applied to the pitted areas on the hull. ,
- \* The first coat of Belzona 5831 applied. ,
- \* The second coat of Belzona 5811 applied. ,

surface of the hull was prepared using high pressure water cleaning. The pitted areas were rebuilt with Belzona 1161. Upon full cure of Belzona 1161, the 1st coat of Belzona 5831 (350 microns) was applied, and finally, within the overcoat time, the second coat of Belzona 5811 (350 microns).
