BELZONA OPERATES IN THE DESERT

ID: 1287

Customer Location: Gas Pipeline, Tunisia
Application Date: August 2006

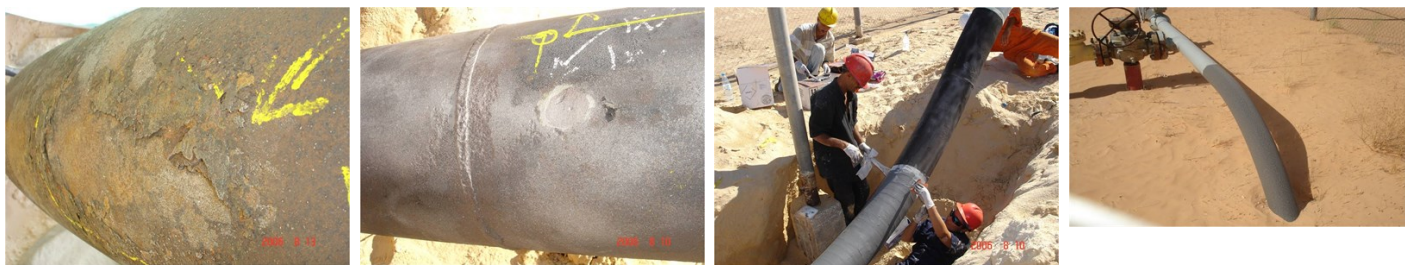
Photograph Descriptions

Pipeline was highly corroded due to external corrosion. Over 60% wall loss was measured on the pipe. Isolating the pipe to change this corroded section would cost millions in production loss.

- * Corroded pipeline before blasting ,
- * Blasted substrate ,
- * Application being carried out ,
- * 2 years later ,

Application was carried out in accordance with Belzona Know-How System Leaflets VPF-11a & TCC-5. Following grit blasting, Belzona 1121 with reinforcement sheet was used to rebuild the wall loss. Belzona 5811 was applied over the repair area to offer corrosion protection.

This repair was completed online and with ambient temperature of 55°C (131°F). and avoided production losses. Following this application, an independant inspection company has approved the repair. 2 years later, the pipe is still in perfect condition and the customer is considering extending the Belzona solution to other sections of the pipeline.
