# BELZONA OPERATES IN THE DESERT

**Industry:** Oil & Gas  
**Application:** VPF-Valves, Pipes and Fittings  
**Substrate:** Carbon Steel  
**Products:** \* Belzona® 1121 (Super XL Metal) ,  
\* Belzona® 5811 (Immersion Grade) ,

**Customer Location:** Gas Pipeline, Tunisia  
**Application Date:** August 2006

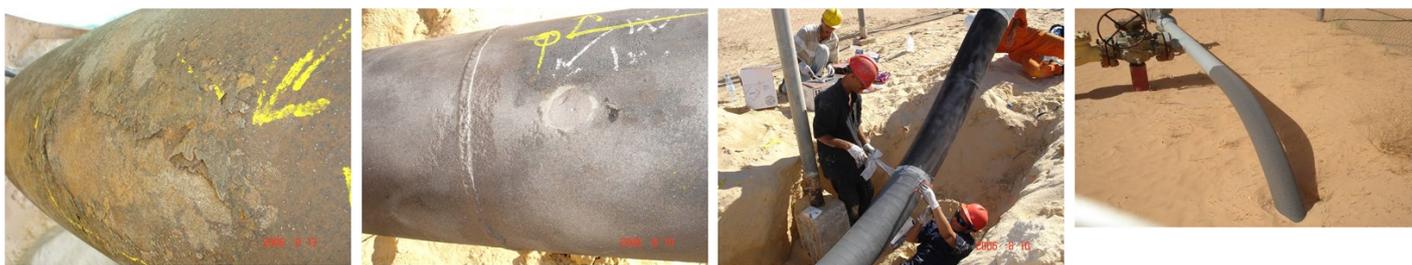
Pipeline was highly corroded due to external corrosion. Over 60% wall loss was measured on the pipe. Isolating the pipe to change this corroded section would cost millions in production loss.

- \* Corroded pipeline before blasting ,
- \* Blasted substrate ,
- \* Application being carried out ,
- \* 2 years later ,

Application was carried out in accordance with Belzona Know-How System Leaflets VPF-11a & TCC-5. Following grit blasting, Belzona 1121 with reinforcement sheet was used to rebuild the wall loss. Belzona 5811 was applied over the repair area to offer corrosion protection.

This repair was completed online and with ambient temperature of 55°C (131°F). and avoided production losses. Following this application, an independent inspection company has approved the repair. 2 years later, the pipe is still in perfect condition and the customer is considering extending the Belzona solution to other sections of the pipeline.
