BELZONA RETURNS PIPELINE PIG BACK TO SERVICE

ID: 1288

Customer Location: *WasteWater Plant, Jordan*
Application Date: *July, 2009*

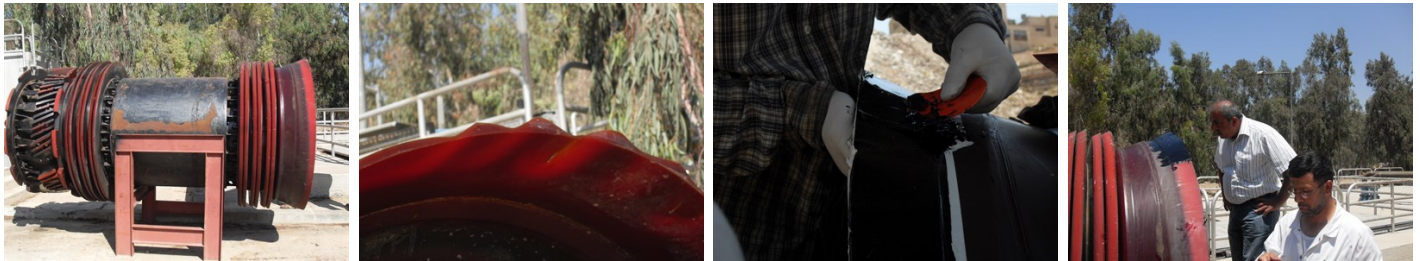
Wear on the rubber tail causes imbalance in the pig.

- * General view of the pig ,
- * View of the worn area ,
- * Rebuilding surface with Belzona® 2111 ,
- * Application is finished and the responsible engineer inspects the application ,

The application was carried out according to Belzona Know-How system leaflet SHM-9. Belzona® 2911 Conditioner was used to ensure maximum adhesion to the substrate.

Applying Belzona was time and cost effective. The conventional way to return the pig to service is by replacing the old rubber tail by a new one which is expensive, needs long time to be imported and takes not less than three days to replace. Belzona application was done in one hour with significant savings in cost.
