BELZONA PROVEN PROTECTION OF STEAM TURBINE

ID: 1290

Customer Location: Vladimirsky Power Plant/ Russia

Application Date: July 2003

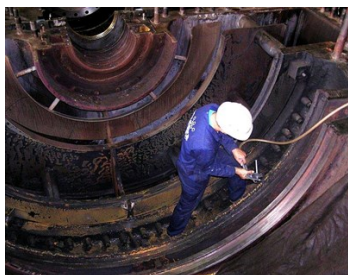
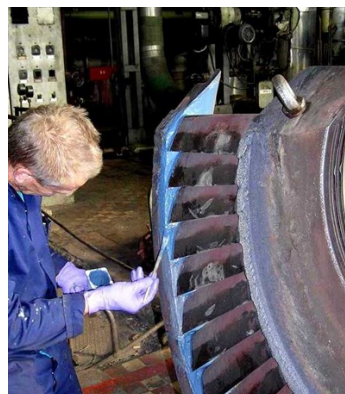
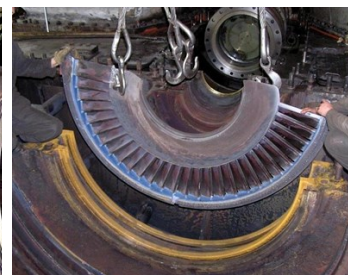
Photograph Descriptions

After more than 35 years (253.000 hours) in-service, inspection during shutdown in 2003, revealed that turbine faced severe stream erosion caused by humid steam. Damages were up to 8 mm wide and 10 mm deep.

* Grit blasting underway , * After blasting extent of damage clearly evident , * Application of Belzona® 1391 , * Completed job ,

Diaphragm and channels under the end journal of medium pressure steam turbine.

Application was carried out in accordance with a modified version of Belzona Know-How System Leaflets CEP-3 & -5.

After 5 years in-service turbine has been inspected (July 2008) and results were very satisfactory. Channel around the nozzle blades had been preserved 95-100%. Also Belzona® 1391 on the rebuilt areas was practically undamaged. In a zone of phase transition, minor damages were easily repaired.
