# BELZONA PROVEN PROTECTION OF STEAM TURBINE

Customer Location: Vladimirsky Power Plant/ Russia

Application: CEP-Centrifugal Pumps

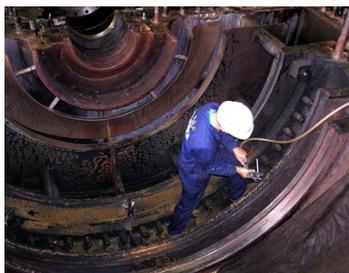
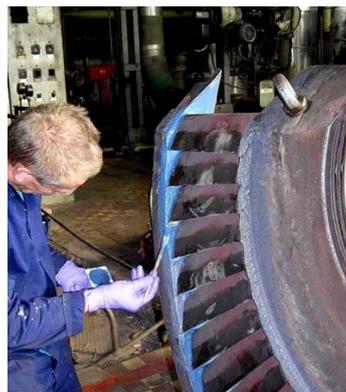
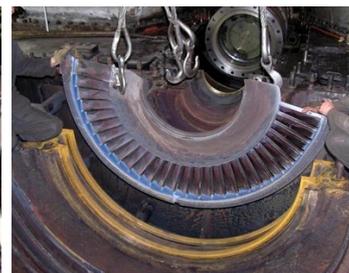
After more than 35 years (253.000 hours) in-service, inspection during shutdown in 2003, revealed that turbine faced severe stream erosion caused by humid steam. Damages were up to 8 mm wide and 10 mm deep.

\* Grit blasting underway , \* After blasting extent of damage clearly evident , \* Application of Belzona® 1391 , \* Completed job ,

Diaphragm and channels under the end journal of medium pressure steam turbine.

Application was carried out in accordance with a modified version of Belzona Know-How System Leaflets CEP-3 & -5.

After 5 years in-service turbine has been inspected (July 2008) and results were very satisfactory. Channel around the nozzle blades had been preserved 95-100%. Also Belzona® 1391 on the rebuilt areas was practically undamaged. In a zone of phase transition, minor damages were easily repaired.
