# BELZONA KEEPS THE LIGHTS BURNING

ID: 1294

Customer Location: Power Station, Western Australia  
Application Date: July 2009

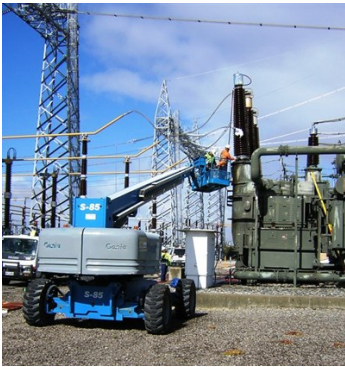
The seal around ceramic bushing had degraded allowing oil to leak out which in turn reduced the operational efficiency of the unit.

- \* General view of site with access from mobile platform ,
- \* Application of Belzona® 1161 applied in conjunction with Reinforcement tape ,
- \* Completing the application ,

Bushing of both blue and red phase of 330KV oil filled transformer. This is a major unit responsible for power supply to a major part of the city.

Application was carried out in accordance with a modified version of Belzona Know-How System Leaflet VPF-11a. A vacuum was drawn on the unit to reduce/stem any oil leak. An MBX Bristle blaster was used to prepare the surface. Belzona® 1161 was used in conjunction with Belzona® 9341 (Reinforcement Tape) to seal over the leaking joints.
