BELZONA KEEPS THE LIGHTS BURNING

ID: 1294

Customer Location: Power Station, Western Australia
Application Date: July 2009

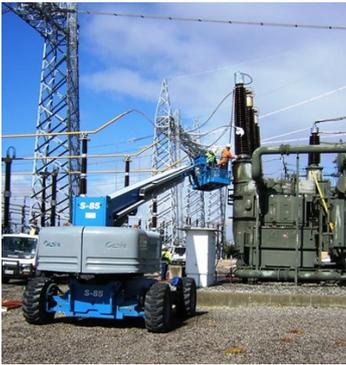
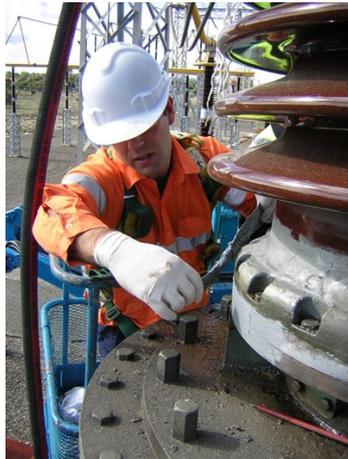
The seal around ceramic bushing had degraded allowing oil to leak out which in turn reduced the operational efficiency of the unit.

- * General view of site with access from mobile platform ,
- * Application of Belzona® 1161 applied in conjunction with Reinforcement tape ,
- * Completing the application ,

Application was carried out in accordance with a modified version of Belzona Know-How System Leaflet VPF-11a. A vacuum was drawn on the unit to reduce/stem any oil leak. An MBX Bristle blaster was used to prepare the surface. Belzona® 1161 was used in conjunction with Belzona® 9341 (Reinforcement Tape) to seal over the leaking joints.
