BELZONA PROTECTS ION-EXCHANGE FILTER

ID: 1295

Customer Location: Power Plant, Moscow, Russia
Application Date: November 2008

Interior coating of ion-exchange filter used to produce water for boilers

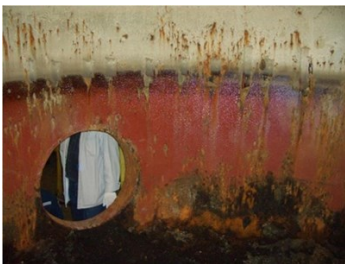
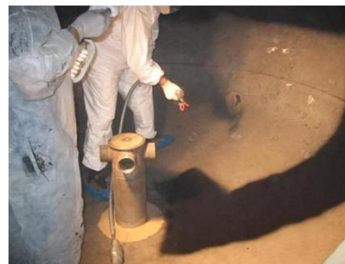
There were blisters, holes and layer of salts under the original polymeric coating after more than 50 years of service. When old coating was removed many corrosion pits in the substrate were detected.

- * Inside the filter ,
- * Damaged areas within the filter ,
- * Spraying Belzona 5811 ,
- * Completed application ,

Application was carried out in accordance with Belzona Know-How System leaflet TCC-5. Deep holes were welded. Small areas of corrosion pitting was rebuilt with Belzona 1111. Coating was applied by heated airless spray.
