BELZONA PROTECTS ION-EXCHANGE FILTER

ID: 1295

Customer Location: Power Plant, Moscow, Russia
Application Date: November 2008

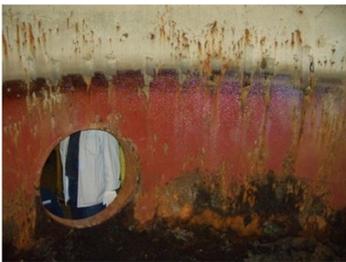
There were blisters, holes and layer of salts under the original polymeric coating after more than 50 years of service. When old coating was removed many corrosion pits in the substrate were detected.

- * Inside the filter ,
- * Damaged areas within the filter ,
- * Spraying Belzona 5811 ,
- * Completed application ,

Application was carried out in accordance with Belzona Know-How System leaflet TCC-5. Deep holes were welded. Small areas of corrosion pitting was rebuilt with Belzona 1111. Coating was applied by heated airless spray.
