# BELZONA SAVES MONEY ON THE REPAIR OF A TRUNNION

ID: 133

Customer Location: Steel Mill in British Columbia  
Application Date: February 1996

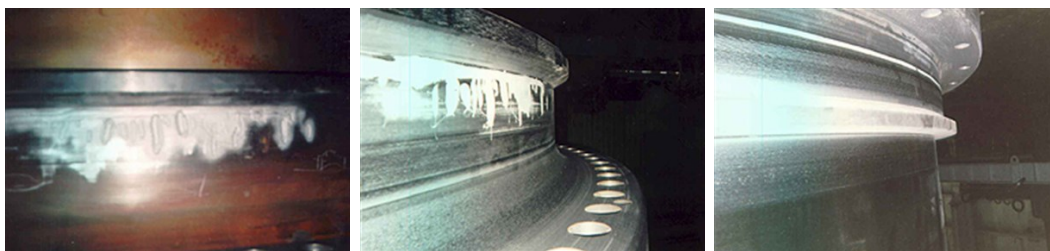
*The seal area of a trunnion bearing had been badly scored by the ingress of foreign matter behind the seal.*

- \* Damaged seal area ,
- \* View of trunnion bearing ,
- \* Repair successfully completed ,

In accordance with Belzona Know-How Leaflet MPT-3.

The customer saved approximately \$150,000. Other repair methods had been tried and had failed. Using the Belzona eliminated the possibility of generating further stress cracks in the casting, removed the anxiety factor associated with welding and the worst case scenario - scrapping the unit.
