BELZONA PROTECTS KORT NOZZLES

Industry: *Marine*
Application: *SOS-Ships and Offshore Structures*

Customer Location: *Tug boat operator, Egypt*
Application Date: *May 2009*

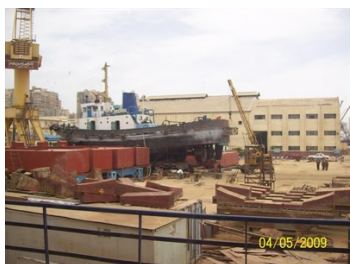
The Kort nozzles were suffering badly from erosion corrosion.

- * The boat in dry dock ,
- * Grit blasting the nozzles ,
- * Applying of Belzona® 1321 ,
- * Completed application ,
