BELZONA RESCUES KOMATSU LOADER

ID: 1334

Komatsu transmission casing

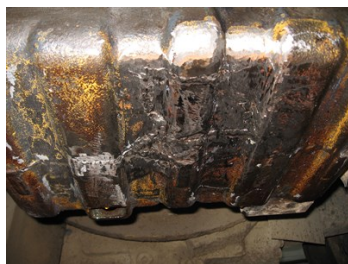
Loader drove over rock and cracked the casing in many areas

- * Loader ,
- * Cracked transmission casing ,
- * Preparation of casing ,
- * Belzona® 1161 after application ,

After trying welding the cracks the oil in this casing continued to leak. That's when Belzona® 1161 came to the rescue. Cost of repair \$1500 vs Komatsu dealer repair over \$20,000. Loader still running after 10 months of operation maintenance free.
