# BELZONA RESCUES KOMATSU LOADER

ID: 1334

Komatsu transmission casing

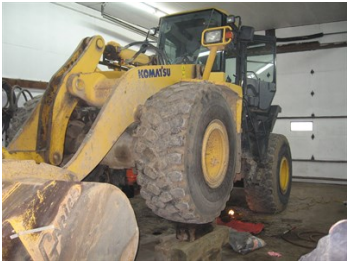
*Loader drove over rock and cracked the casing in many areas*

- \* Loader ,
- \* Cracked transmission casing ,
- \* Preparation of casing ,
- \* Belzona® 1161 after application ,

After trying welding the cracks the oil in this casing continued to leak. That's when Belzona® 1161 came to the rescue. Cost of repair \$1500 vs Komatsu dealer repair over \$20,000. Loader still running after 10 months of operation maintenance free.
