# BELZONA KEEPS TIRE ROLLING

Industry: *Mining & Quarrying*  
Application: *SHM-Solids Handling Machinery*

Customer Location: *Mine, Canada*  
Application Date: *July 2005*

Substrate: *Rubber*  
Products: *\* Belzona® 2211 (MP Hi-Build Elastomer) ,*

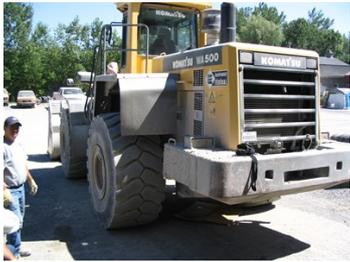
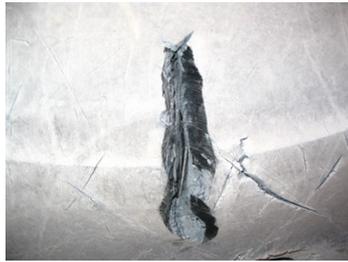
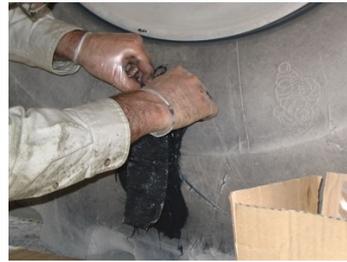
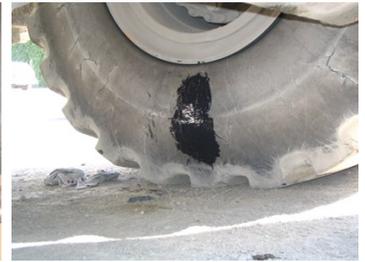
## Photograph Descriptions

*Damage on tire sidewall was exposing steel reinforcement to corrosion*

\* The equipment Crack was veed out and prepared with Belzona roughing brush Belzona® 9341 (reinforcement Tape) incorporated for additional strength The completed repair ,

Damaged tire needed fast insitu repair.

Application was carried out in accordance with Belzona Know-How System Leaflet SHM-9.

Belzona repair carried out quickly with tire in place. high adhesion and elasticity of Belzona Elastomer copes with extremes of service and protects tire from further deterioration.
