BELZONA KEEPS TIRE ROLLING

ID: 1336

Industry: *Mining & Quarrying*
Application: *SHM-Solids Handling Machinery*

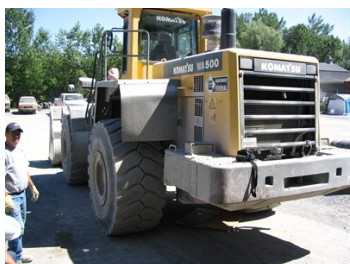
Damage on tire sidewall was exposing steel reinforcement to corrosion
