# BELZONA REPAIRS AND PROTECTS 18 FOOT DIAMETER FLANGE FACE

ID: 1337

Flange on 18ft. diameter evaporator.

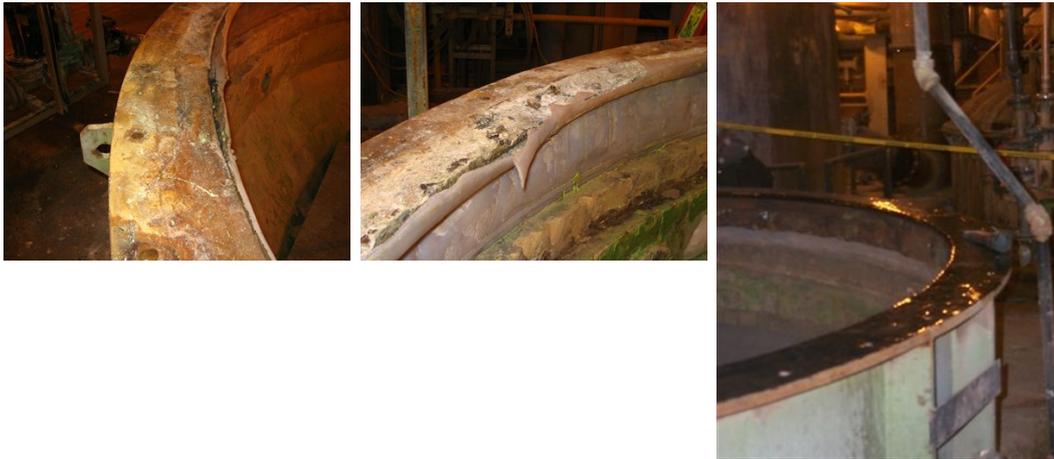
*Flange was attacked by 98% Sulfuric acid at elevated temperature after Teflon lining was damaged.*

- \* Metal flange needed rebuilding. ,
- \* The damaged Teflon lining that caused leak ,
- \* The rebuilt flange protected with Belzona® 4341 ,
- \* ,

Application carried out in accordance with Belzona Know-How System Leaflets GSS-8 and HEX-3. Templates were used to obtain original profile of the flange with Belzona® 1111. Belzona® 4341 was applied as a protective coating.

Belzona solution restored sealing on flange face without heat avoiding further damage to the Teflon lining. Use of Belzona® 4341 provided acid resistance to the repair.
