# BELZONA RELINES ABSORBER TOWER IN PETROCHEMICAL PLANT

**Industry:** Chemical & Petrochemical  
**Application:** TCC-Tanks and Chemical Containment Areas  
**Substrate:** Carbon Steel  
**Products:** \* Belzona® 1311(Ceramic R-Metal) ,  
\* Belzona® 1321(Ceramic S-Metal) ,

**Customer Location:** Petrochemical Complex in Venezuela  
**Application Date:** March 1995

MEA-CO2 Absorber tower - 18m high, 2.3m diameter in Ammonia Plant

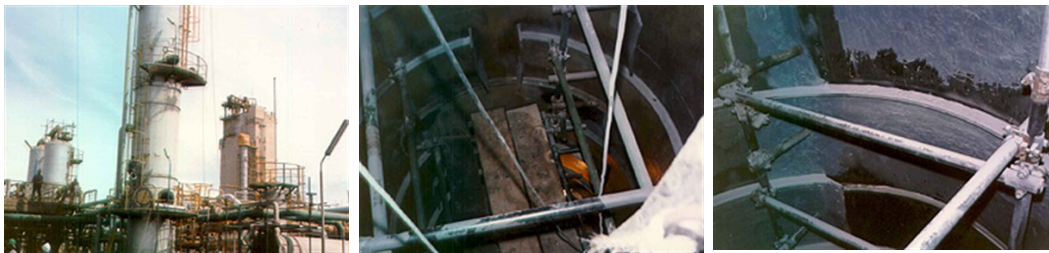
*Erosion of the tower lining by the fluids it contained had previously been repaired by the clients own staff. Surface preparation had not been sufficiently good and the repair had failed by peeling.*

- \* The absorber tower ,
- \* Internal scaffolding erected and surfaces prepared ,
- \* The repair in its final stages ,

In accordance with Belzona Know-How Leaflet TCC-5.

Replacement of the absorber tower would have been costly, both in time and in money. Welding the eroded areas presented a safety risk, due to the volatile mix of chemicals in the surrounding location. The decision to go with a Belzona repair system saved the company over £70,000, many weeks of lost capacity and provided a hazard-free solution.
