# BELZONA REBUILDS FLANGE FACE ON FILTER

ID: 1346

Customer Location: Hydroelectric Power Plant, Russia  
Application Date: December 2007

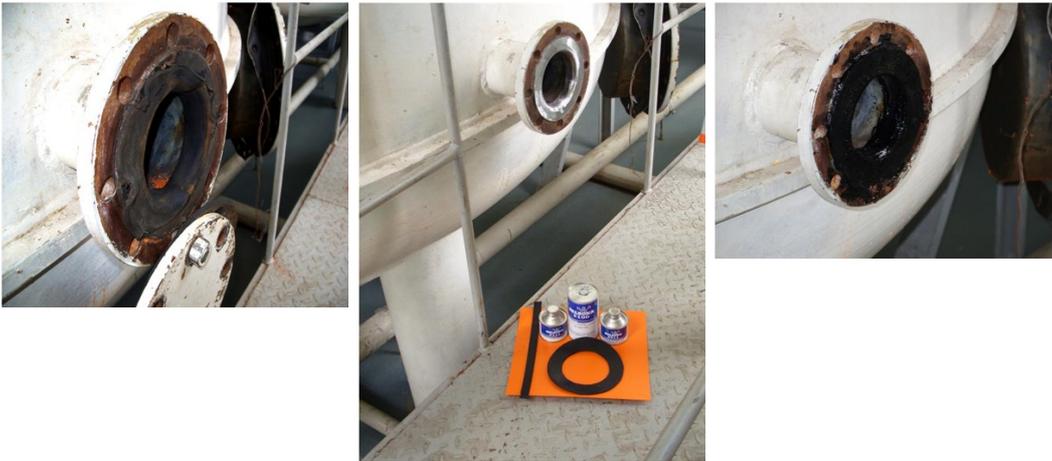
Rubber had been damaged due to long years in service and was badly deteriorated. Sealing of the flange lost. Rubber in seal area had lost adhesion to the substrate.

- \* Deteriorated flange face before the application ,
- \* Surface preparation to flange face ,
- \* Completed application ,
- \* ,

Application was carried out in accordance with Belzona Know-How System Leaflet VPF-13. A plastic former was manufactured and coated with Belzona® 9411 (Release Agent) before being used to form the Belzona® 2111 to precise contours.
