# BELZONA RECONSTRUCTS STREET SWEEPER FAN

ID: 1348

Industry: *General Industry*  
Application: *FBC-Fans, Blowers and Compressors*

Customer Location: *Local municipality, Québec Canada*  
Application Date: *March 2005*

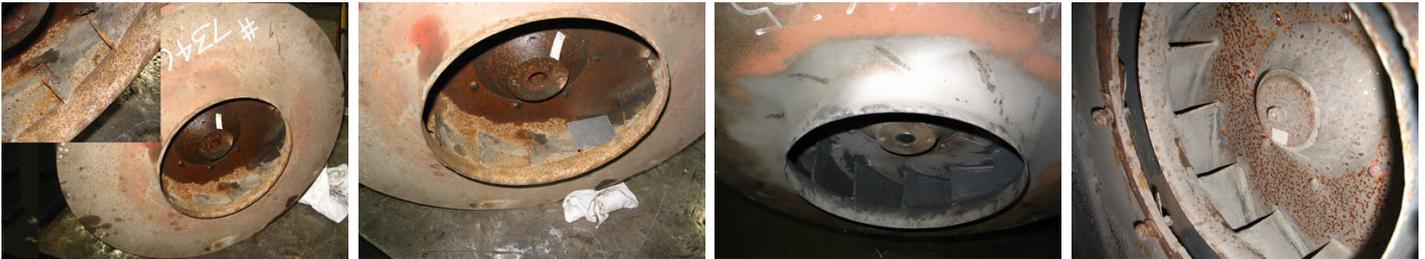
*Wear on the blades of the fan. Customer wanted to avoid replacing the part.*

- \* Overall view of the fan and the wear on the blades ,
- \* Steel plate being shaped in place ,
- \* Plate being placed and coated with the Belzona 1311 ,
- \* Inspection after 3 years shows no significant wear ,

Application was carried out in accordance with Belzona Know-How System Leaflet FBC-15. Steel plates were prepared for each blade to give back some structure. These plate were bonded in with the Belzona

The customer saved \$4000 from an investment of only \$400 in Belzona because the fan didn't need to be replaced. An inspection 3 years later showed no significant wear.
