# BELZONA PROTECTS STREET SWEEPER

Application: *SHM-Solids Handling Machinery*

Customer Location: *Local municipality, Québec Canada*

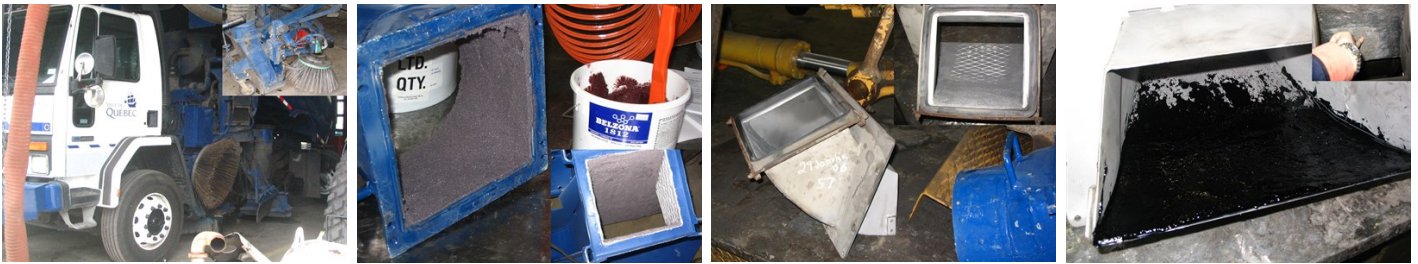
## Photograph Descriptions

*Abrasion on the nozzle and on the duct. Customer wanted to prevent the abrasion and impact damage.*

- \* Example of a Elgin vehicle with the parts ,
- \* Belzona® 1812 applied on the nozzle and parts ,
- \* The design of the busher parts receive more impact. Belzona® 1812 was able to resist perforation of the elbow. ,
- \* With the use of Belzona® 2111, no more wear even after 500 hours ,

The application was carried out in accordance with Belzona Know-How System Leaflet SHM-8. Expanded metal was tack welded into position to assist rebuilding with Belzona® 1812. Belzona® 2111 found to give improved protection on high wear areas.

Without the Belzona, this equipment lasted less than 500 hours, one year's season (spring to fall). With Belzona® 1812 as a coating, inspection showed very small wear and was useable another season after some touch up. In some areas, impact was more severe and the use of Belzona® 2111 resulted in no wear after 500 hours.
