STREET SWEEPER FAN PROTECTED WITH BELZONA

ID: 1350

Industry: General Industry
Application: FBC-Fans, Blowers and Compressors

Customer Location: Local municipality, Québec Canada
Application Date: May, 2006

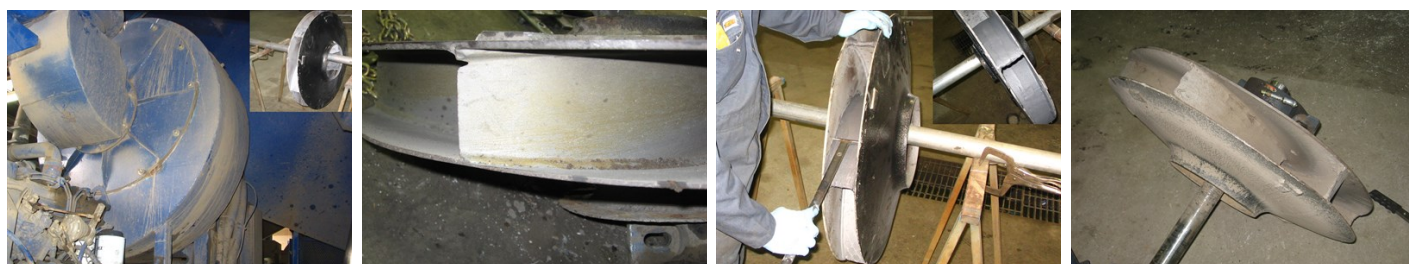
Photograph Descriptions

The blades on the fan are submitted to severe abrasion caused by solid particles entering the street sweeper.

- * Location of the fan on the vehicle ,
- * View of the damage to the fan ,
- * Application of Belzona® 1311. The fan needs dynamic balancing before being used ,
- * The inspection after one year shows the Belzona® 1311 in excellent shape ,

Application carried out in accordance with Belzona Know-How System Leaflet FBC-15. Expanded metal was used with the Belzona to re-create correct profiles.

The customer invested in 2 units of Belzona® 1311 and saved on a brand new fan which would have cost \$4000.00. After 500 hours, one season, the fan is in excellent condition and no touch up was necessary.
