# Belzona Waterproofs Sunroom Roof

ID: 1352

Customer Location: *Residential Roof in Ontario*  
Application Date: *June, 2009*

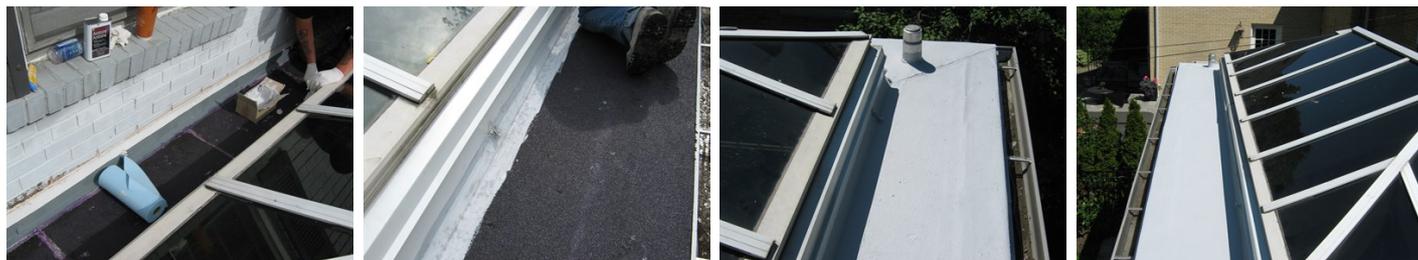
*The roof and flashing on this customers sunroom was allowing water to enter and damage walls and belongings.*

- \* Applying Belzona® 3911 (Conditioner) ,
- \* Initial application of Belzona® 3111 incorporating Reinforcing sheet in 1st Coat ,
- \* & 4 Finished application ,

A poor roofing job left customer with a leaking sunroom.

Using modified Belzona Know-How Systems Leaflet RPA-1, a fully reinforced Belzona® 3111 System was applied.
